LESSONS LEARNT: STEEL AND METALS HAND INJURY

LOCATION: MERSEY STEEL AND METALS TERMINAL

WHEN: 27TH JUNE 2023

Ref: LL 07 23

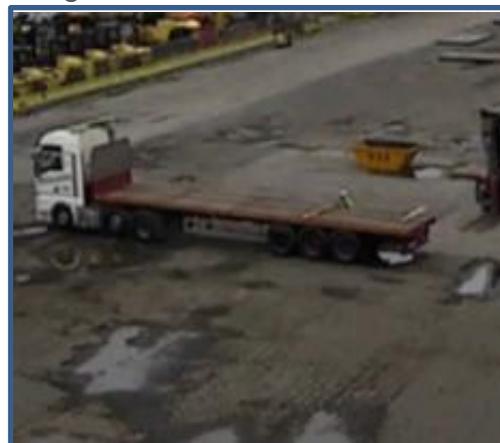
Image 1

After the plates had been deposited on the first flatbed, a final lift was made to allow adjustment of a timber bearer which had fallen on its side. As one HGV driver adjusted the bearer by hand (with load suspended by the forklift) his finger became trapped and was injured.

A Safe System of Work (SSOW) including 3m safety zone, had been briefed to staff, but was not fully implemented.

- Limited safety supervision and oversight was provided.
- Prior to loading, the injured HGV driver had not been removed to a place of safety, as per the SSOW.
- HGV drivers arriving at this terminal are not always informed of the site's safety rules and our expectations of them.
- The HGV driver brought unsuitable timber bearers of rectangular (not square) section. One fell onto its side, prompting correction.

1. No vehicle may be loaded/unloaded by forklift unless all persons have been fully removed from the demarcation zone to a position of safety.
2. HGV drivers must either remain in their cab or be sent to a marked, safe zone, visible to the forklift driver and supervisor/banksman.
3. No one may approach the trailer unless the forklift has fully withdrawn, the loading/unloading operation has ceased and the supervisor/banksman has granted permission.
4. If a bearer requires adjustment, the forklift must withdraw the load fully and not approach again until all persons involved have returned to a place of safety under supervision.
5. Everyone has 'Stop the Job' authority and MUST intervene if they see any contraventions of our safe systems of work.
