## **MARINE SAFETY ALERT**

Safety Alert 11-23

## **SHIPBOARD CRANE WIRE ROPE HAZARD MITIGATION**

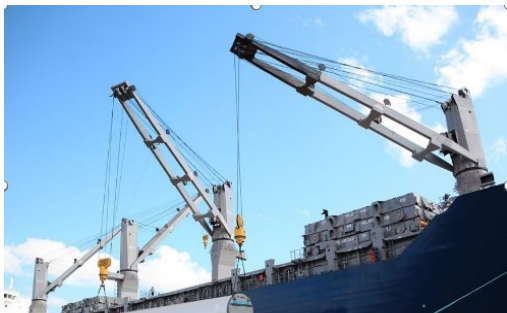
*Figure 1: Cargo ship offloading cargo utilizing shipboard cranes. Photograph courtesy of Macgregor.com.*
