Safety Bulletin 1 /2025

Dropped steel cargo

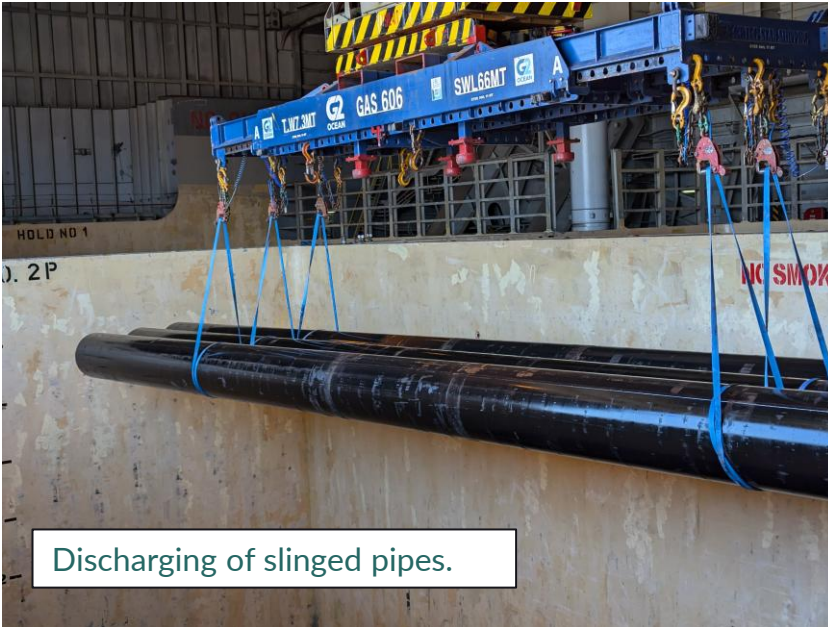
Discharging of slinged pipes.

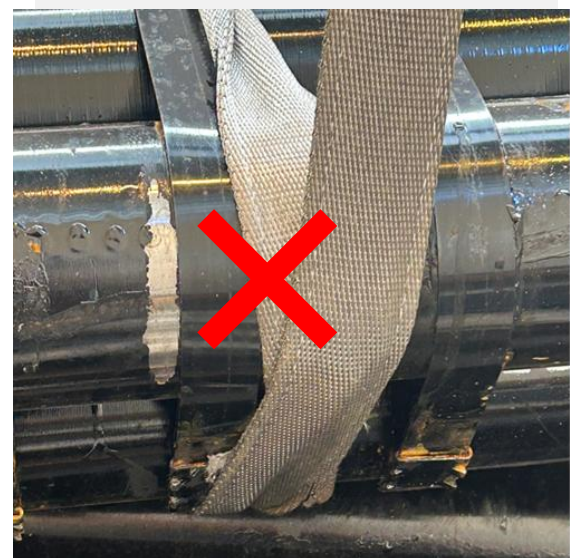
The risk increases if steel bands, used to bundle cargo items together, are touching the lifting slings. The sharp band can potentially cut the softer sling material during the lift. This unsafe condition was rectified before the lift.

- The crane operator must avoid abrupt movements.
- Use sufficient dunnage in the correct positions, to protect the slings from chafing during the sea voyage.
- Put the slings in the correct position, away from sharp bands and edges.
- Inspect slings to the extent possible, before the lift.
- Final check: Pause for a moment at the start of every lift, with all persons at safe distance.

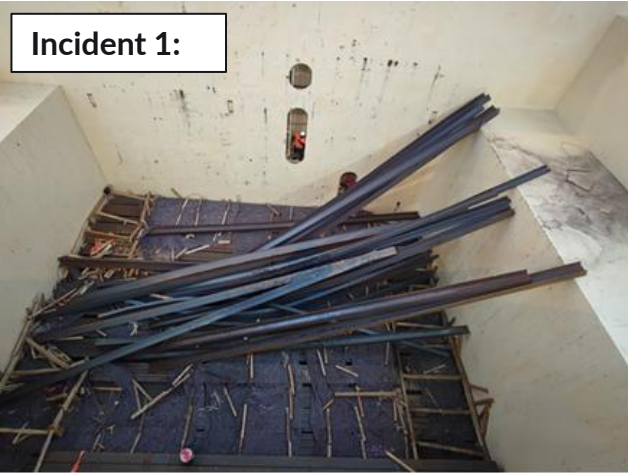
Incident 1:

A bundle of H-beams dropped when the below wire sling parted during the crane lift. Likely cause: Chafing during the sea voyage and contact with a sharp cargo edge had damaged the wire prior to the lift.

- In both incidents there was damage to the vessel's ballast tanks, causing delays.
- Potential injuries, which could be fatal for stevedores and crew .

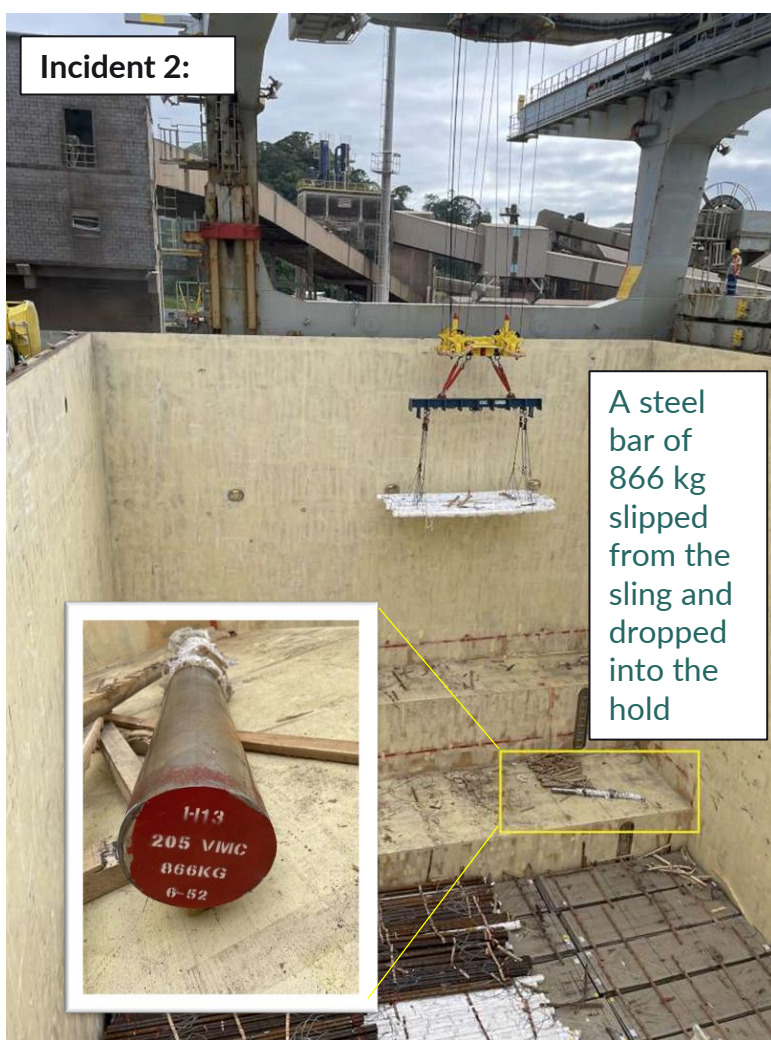
Incident 2:

A steel bar of 866 kg slipped from the sling and dropped into the hold
