# Safety Bulletin 2 /2025

## Safety and productivity

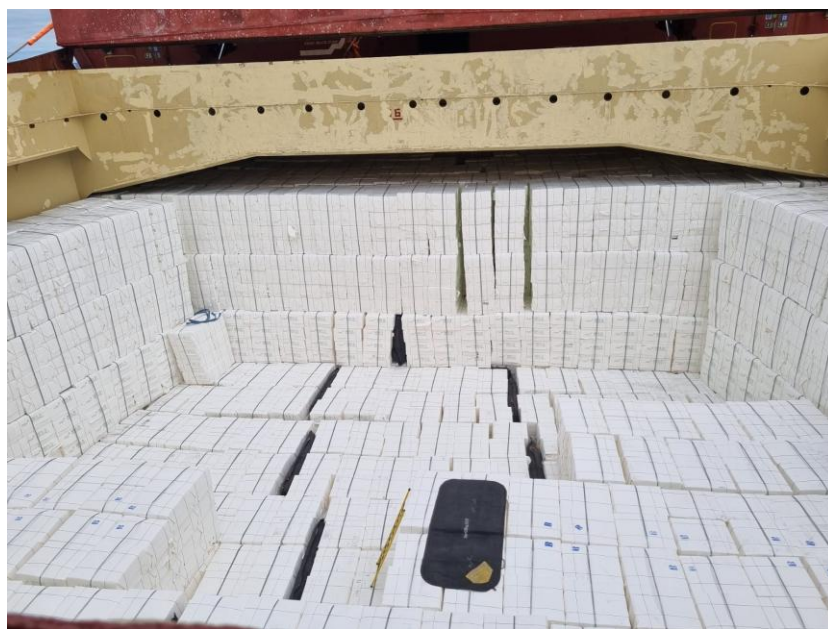
Loading pulp is a bit like Tetris, in 3D. This cargo hold has an overhang, increasing the difficulty level.

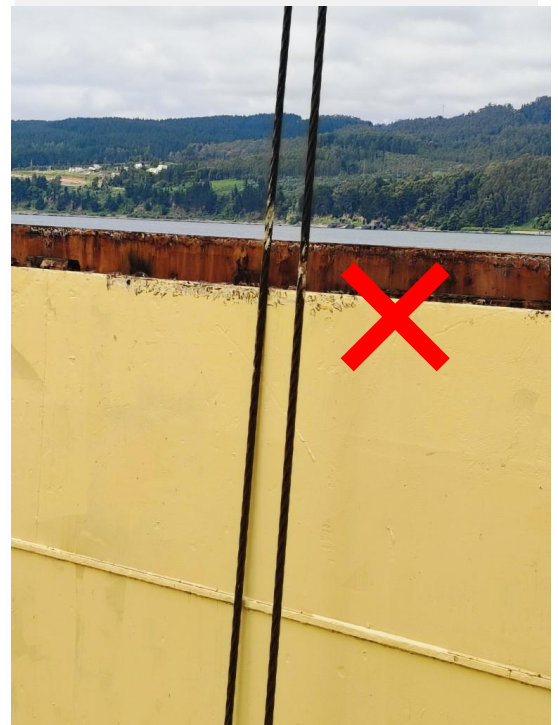
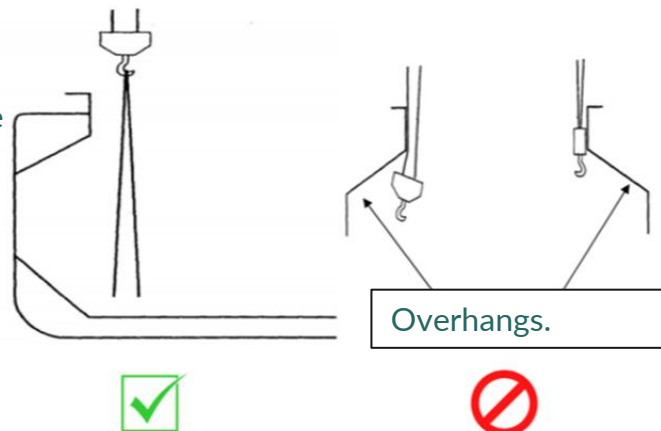
Not all cargo holds on our vessels have a perfect box shape, and this increases the risk of the crane wire rope touching the ship structure.

During a recent loading operation, a person observed the crane wire rope rubbing against steel and stopped the operations.

A safe solution was found! After the intervention, it was decided to load the pulp into the center of the cargo hold and then use forklifts to move them to the area below the overhang. The stow pattern has been changed for future shipments, reducing the risk of wire touching steel to almost zero.
